POSTLAUNCH REPORT

MERCURY-REDSTONE NO. 2

(MR-2)

Space Task Group

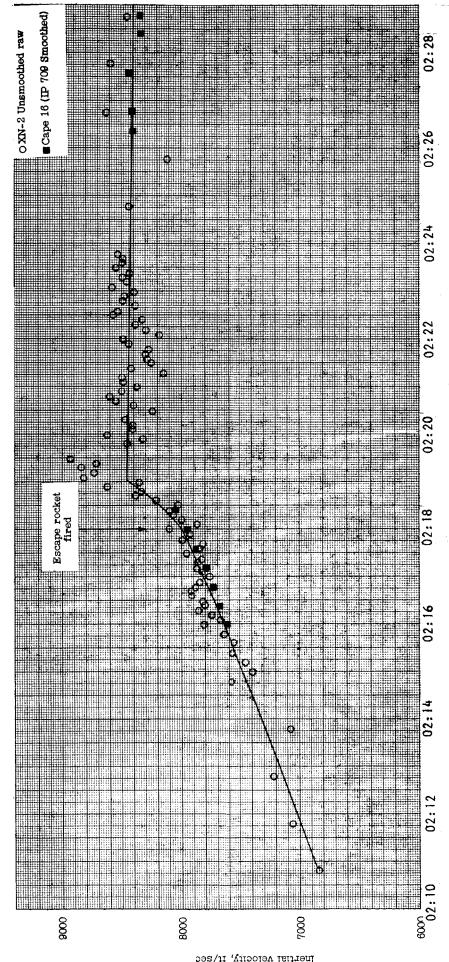
Figure 6.1-9.* Inertial velocity in the region of fuel depletion and tower rocket firing.

The inertial velocity in the region of fuel depletion and escape rocket firing is shown in Figure 6.1-9. Smoothed Cape FPS-16 data and raw GBI XN-2 data were used to derive velocity. The relatively high points from XN-2 at the time of 02:19 are believed to be erroneous because of the method of data reduction used. The inertial velocity gained from the escape rocket is about 450 ft per sec. This is approximately the value that would be expected for these flight conditions. A discussion of trajectory computing equipment, data from system operation, and plotboard displays are presented in the Appendix.

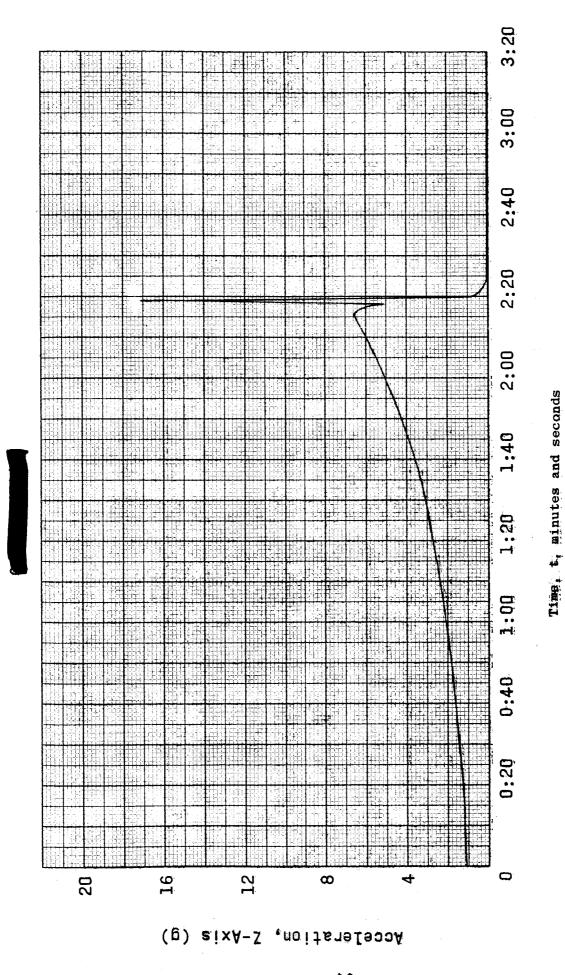
Figure 7.1.1-1. - Longitudinal Acceleration (Exit)

The longitudinal acceleration data are presented in Figures 7.1.1-1 and 7.1.1-2 for the exit and re-entry, respectively. The acceleration increased from 1.2 g at lift-off to 6.5 g at 02:17, the time of booster cutoff. At 02:18 the capsule began the abort sequence. Peak acceleration during escape rocket firing was 17.0 g. After escape rocket firing, the acceleration decayed to zero and the period of weightlessness began and continued for about 6-1/2 minutes. First measurable deceleration occurred during re-entry at 09:20, reaching a maximum of 14.6 g at 09:36 and decaying to 1.3 g at loss of telemetry signal (10:20) at Cape Canaveral. Examination of onboard records showed that drogue chute deployment caused a pulse of less than 0.5 g at 10:54 and that a 3 g pulse was experienced at deployment of main chute at 11:28. Throughout the flight, lateral and normal accelerations were small prior to landing.

Both the maximum longitudinal and normal accelerations were roughly twice the values experienced in qualification air drops of the impact bag system in a rough sea condition. It was not possible to determine the sea condition, surface winds, and capsule attitude at impact for the MR-2 flight, but the rate of descent is known to be normal.

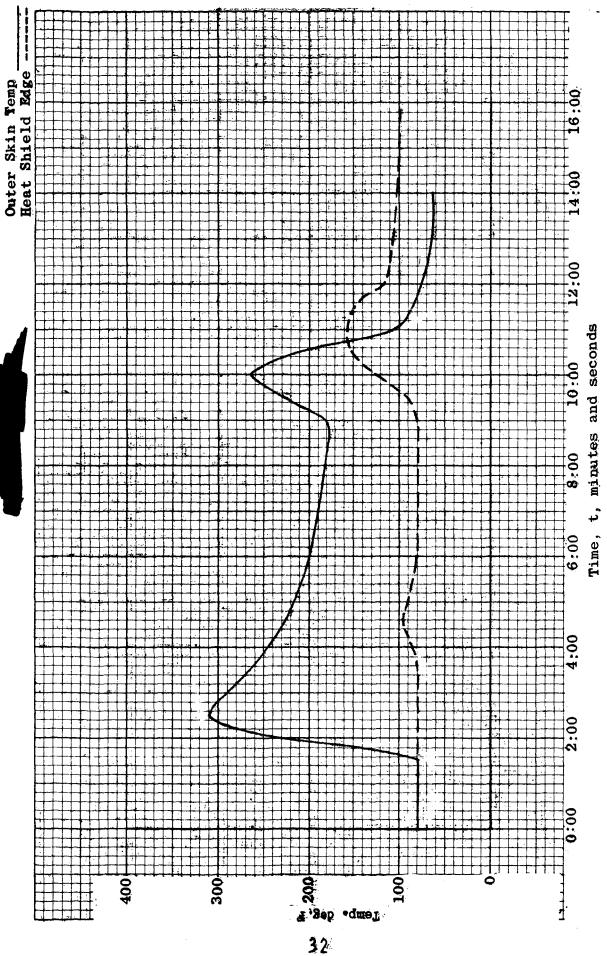
Figure 7.1.2-1. - Variation of Outer Skin and Heat Shield Edge temperature with time.

Outer skin temperature, Figure 7.1.2-1, rose to a maximum of 310° F during exit. Maximum outer skin temperature during re-entry was 255° F. These temperatures are as would be expected.

Heat sink edge temperature, Figure 7.1.2-1, did not rise appreciably until re-entry, at which time a maximum temperature change of 80°F was measured.

The above temperatures are consistent with the trajectory flown.

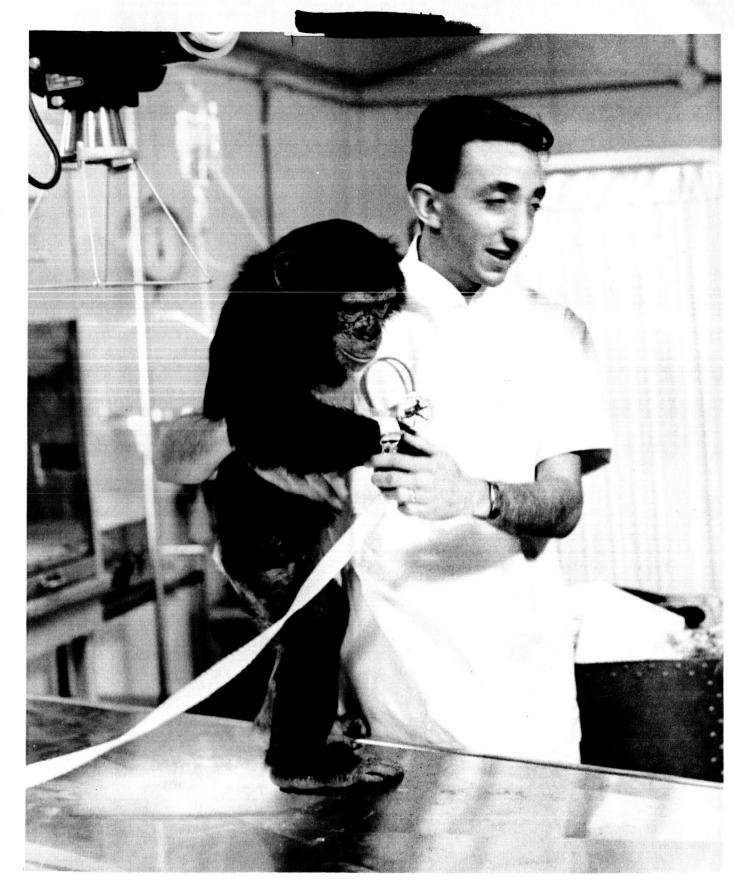
FIGURE 8.3-1 CHIMPANZEE AFTER FLIGHT 58

Examination of the couch on the DONNER following pickup showed one to two teaspoonfuls of very recently deposited mucous or vomitus which was flecked with blood. It is believed that the animal struggled and swallowed air while on his side in the water and that he belched up a small amount when the capsule was righted during the helicopter flight. The blood flecks appear to have derived from a small self-inflicted abrasion on the bridge of the nose. This finding is considered a post-flight occurrence and irrelevant to the flight itself.

At 0830 EST on the following day, another physical examination of the animal was performed at the Downrange Land-based Medical Facility on Grand Bahama Island. The results of this more complete examination were the same as those obtained on the DONNER. In addition, a chest x-ray was taken. It showed no abnormalities. At 1300 EST, the animal was transferred by aircraft to the compound at Hangar S where on February 2, he was further checked and found to be normal and fit for work on his couch.

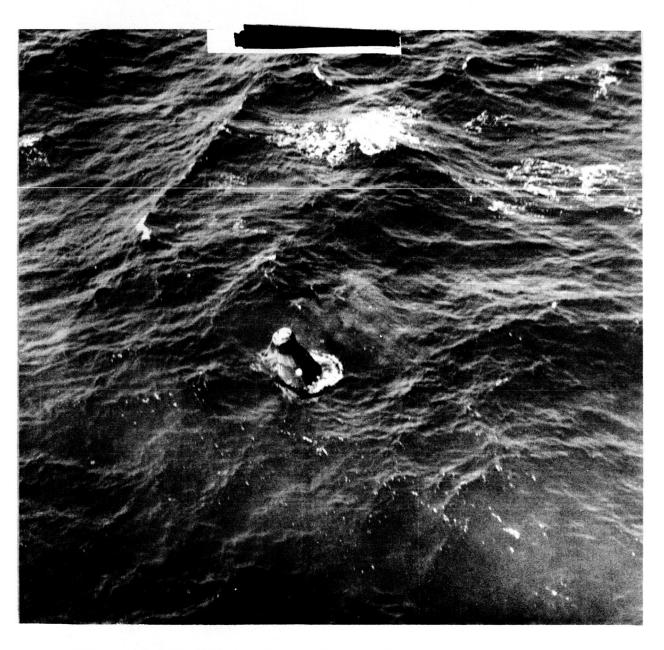
Figure 10.2-1. - Capsule - Soon after landing.

The first electronic bearing was obtained at 12 minutes and the first sighting after landing was by aircraft at 45 minutes, at which time the capsule appeared upright and normal. By the time the capsule was picked up by helicopter at 2 hours, 56 minutes, it was lying on its side with the cylindrical part of the capsule almost submerged in the water. At pickup, the bag was shredded, the straps were broken and the heat sink was missing. The capsule was delivered to an awaiting LSD where the chimpanzee was removed, alive and well. Approximately 800 pounds of sea water was in the capsule.

A photograph of the capsule taken from an aircraft during the first time period is shown as Figure 10.2-1, and during the last time period as Figure 10.2-2.

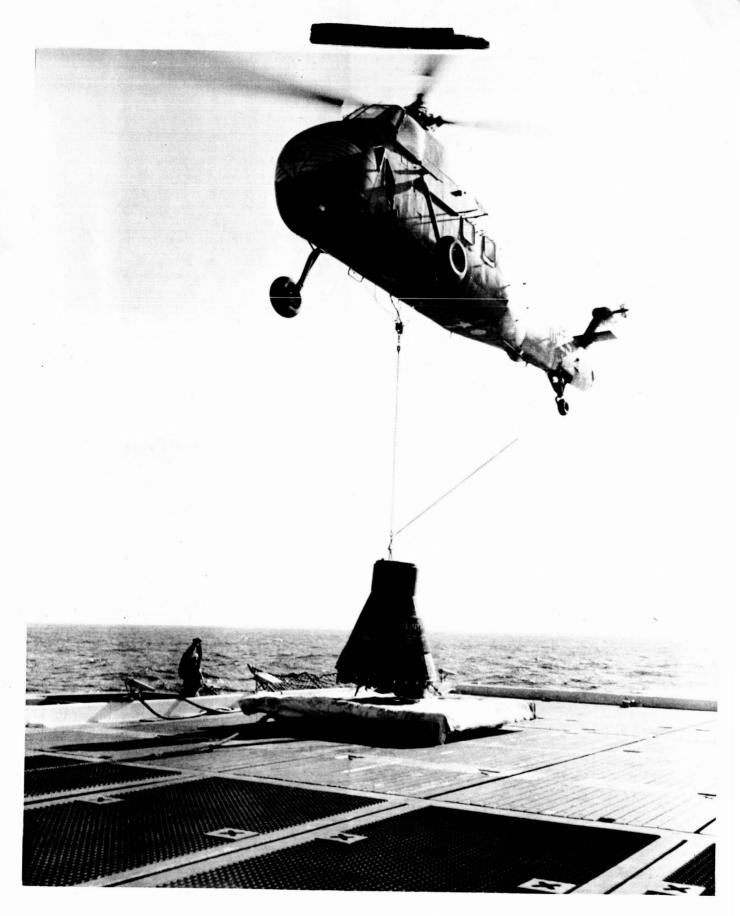
Figure 10.2-3. - Capsule being placed on LSD, Donner.

Helicopters were launched to arrive at the landing position as early as practicable, ships continued to close at maximum speed and the first unit on scene was directed to retrieve. At 2 hours 56 minutes, the capsule was retrieved from the water by helicopter and placed on the LSD at 3 hours 47 minutes (Figure 10.2-3).
